Technical Paper

A Case Study on Condition Assessment of Fire-Damaged RC Members of Turbo-Generator

Sanjay Mundra*, TVG Reddy, Nitesh Kumar, Shivang Bansal, P N Ojha

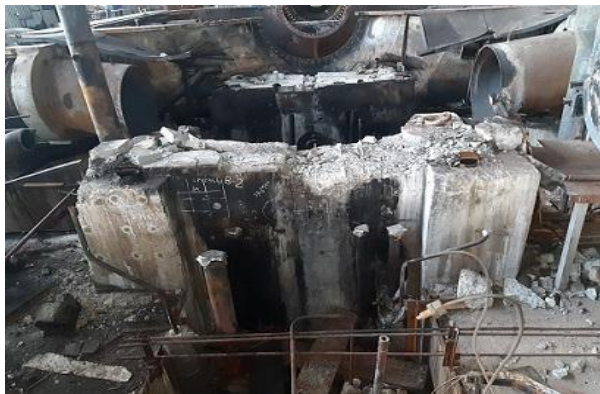
In phase-1, preliminary inspection data was collected along with photographs. As per information collected from eyewitnesses present during a fire, the fire was initiated near concrete bearing pedestal B2 and the dousing of the same was done within 2 hours. The surface of concrete bearing pedestals showed a change in colour from grey to blackish-grey along with deposition of soot. Spalling and crushing were also observed at the top portion of the concrete bearing pedestal. The information extracted from the structural

Fig. 2 – Spalling and crushing of top chemical grout along with underneath concrete and black stains of the fire-damaged face of Pedestal B2

The visual inspection indicated the crushing and spalling of top grout and underneath concrete was observed at concrete bearing pedestals of B2 and B4 (as shown in Figure 2 and Figure 3). The crack width and depth were measured by using a crackoscope and UPV equipment, respectively. In addition to soot, inclined cracks initiated from the top and extended to downward direction were also observed on concrete bearing pedestal B2 (width varies from 0.25 to 0.4 mm, depth varies from 73 to 112 mm, and length of approx. 350 mm). No such cracks were observed on concrete bearing pedestal B4. Deposition of soot on a small portion of the deck slab soffit was also observed. However, no deposition of soot and change in colour were observed at supporting columns. Side and top reinforcement were exposed at a few locations on a pedestal bearing B2. Change in colour from grey to black was observed on cores extracted from concrete bearing pedestal B2 as shown in Figure 4 and Figure 5. Based on the visual inspection it was observed that concrete bearing pedestal B2 was moderately distressed while pedestal B4 and deck slab were in the minor distress category and no apparent distress was observed on supporting columns.

Further, the repair was proposed for a distressed concrete bearing pedestal using micro concreting at crushed portion followed by FRP wrapping. For inclined cracks, epoxy grouting was proposed. The protective coatings were also suggested for all repaired and non-repaired portions for improving the performance of RC members of the TG unit. This

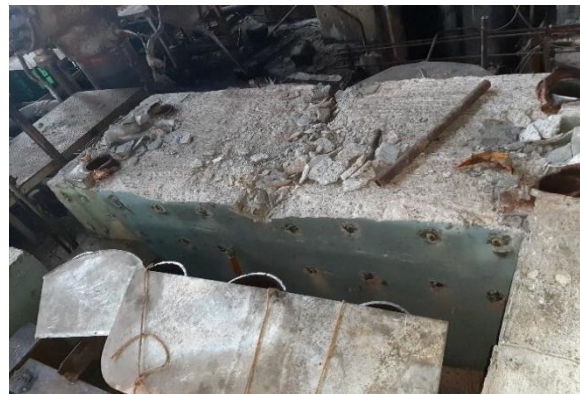
Fig.3 – Spalling and crushing of top chemical grout of Pedestal B4

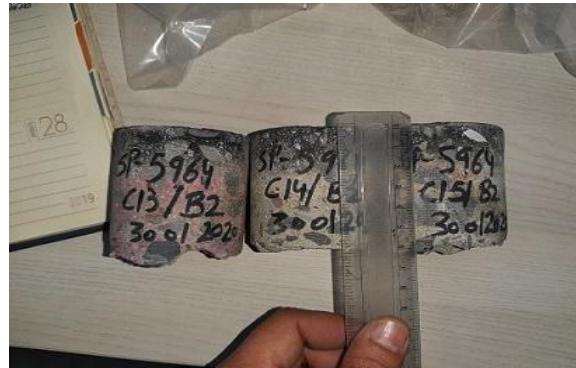
Fig. 5 – Colour change to a blackish grey colour in the cover region of concrete bearing pedestal B2.

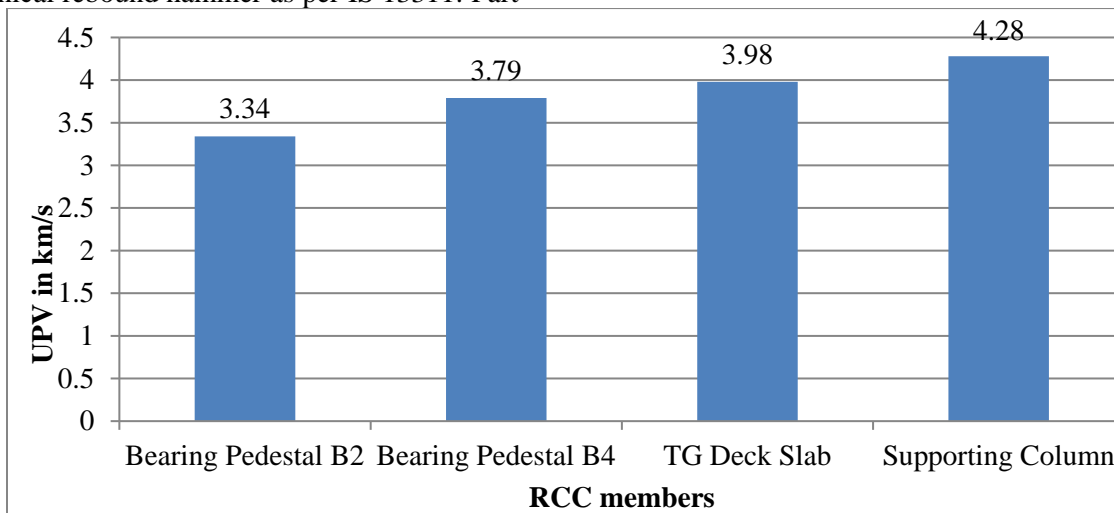
Ultrasonic Pulse Velocity measurements were carried out by the cross-probing method at different locations as per IS 516: Part 5: Sec 1: 2018 [12] to assess the quality of concrete in RCC members of the TG unit. The average results of the UPV test on pedestal B2 and B4 were found to be 3.34 km/s and 3.79 km/s, respectively, which indicates that the overall quality of concrete was found to be doubtful in bearing pedestal B2 and good in bearing pedestal B4. The same was supported by Kore et al [13] that there was a decrease in UPV results of fire exposed members. For deck slab and supporting columns, the results were found to be 3.98 km/sec and 4.28 km/sec, respectively, which indicates the overall quality of concrete was good.

Fig. 6 – UPV (by cross probing method) of various RCC members of the TG unit

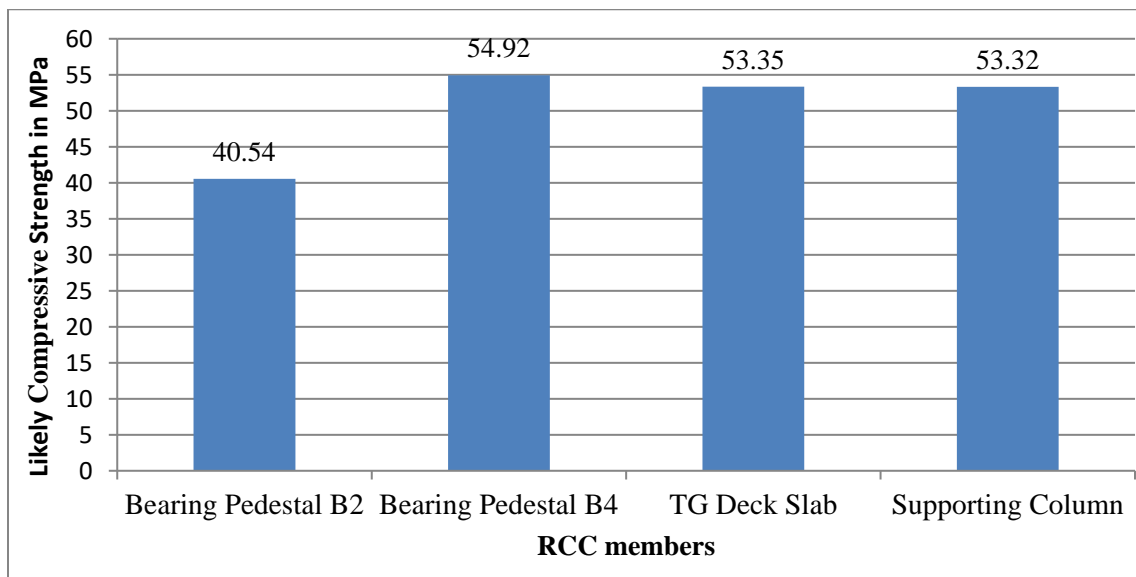
2: 1992 [14] to predict the likely compressive strength of the fire and non-fire damaged members of the TG unit. The results obtained by Rebound Hammer testing on fire damage concrete bearing pedestal B2 (as shown in Figure 7) indicate the average likely compressive strength of 40.54 MPa, and for non-fire damaged concrete bearing pedestal, i.e., B4 likely compressive strength is 54.92 MPa. The rebound hammer test on other non-fire damage RCC members (TG deck slab and supporting columns) indicates 53.35 MPa and 53.32 MPa, respectively. These results show that the rebound test gives less likely compressive strength on the fire-damaged portion than non-fire damaged, and the variation is approximately 26%. Similar results were also observed by Wróblewska J. et al. [15].

Fig. 7 – Likely Surface Compressive Strength of RCC members of TG unit

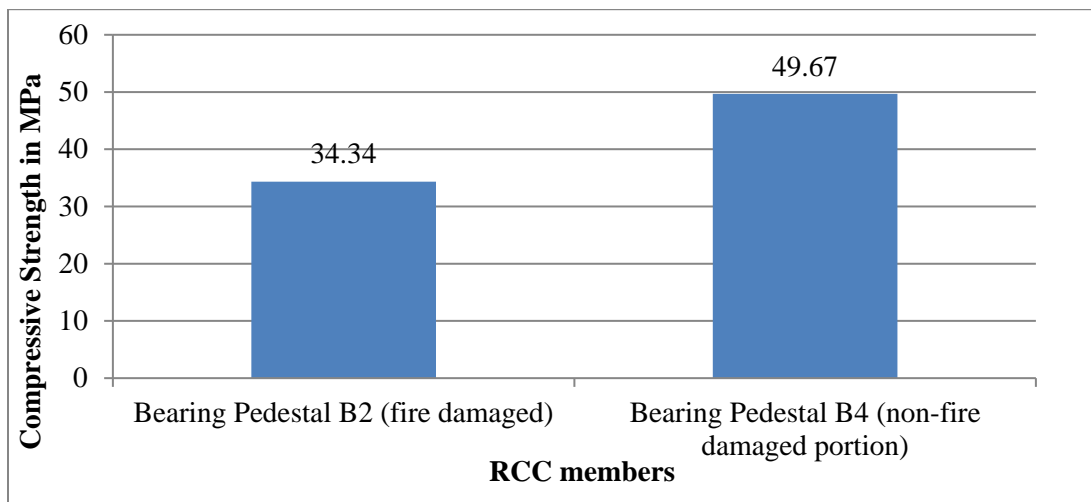
The cores of 60 mm diameter were extracted from fire-damaged and non-fire damaged locations through a core drilling machine for estimating the compressive strength of in-situ concrete. Its equivalent cube compressive strength was assessed duly by applying the correction factors, i.e., diameter, length/diameter ratio, etc., as per clause 8.4.2 of IS 516: Part 4: 2018 [16]. The average compressive strength of cores extracted from the fire-damaged portion of pedestal B2 and non-fire damaged portion of pedestal B4 were 38.51MPa and 49.67MPa (as shown in Figure 8), respectively. The results are satisfying the requirement of the M 35 grade of concrete. The member exposed to high temperature resulted in a reduction in compressive strength approximately by 22%. Similar trend was observed by Xiao et al [17] for the reduction in residual compressive strength with the increase in temperature. Heating up to 400°C generated relatively small cracks, which did not cause any immediate loss of carrying capacity in compression.

Fig. 8 - Equivalent Cube Compressive Strength of RCC members of TG unit

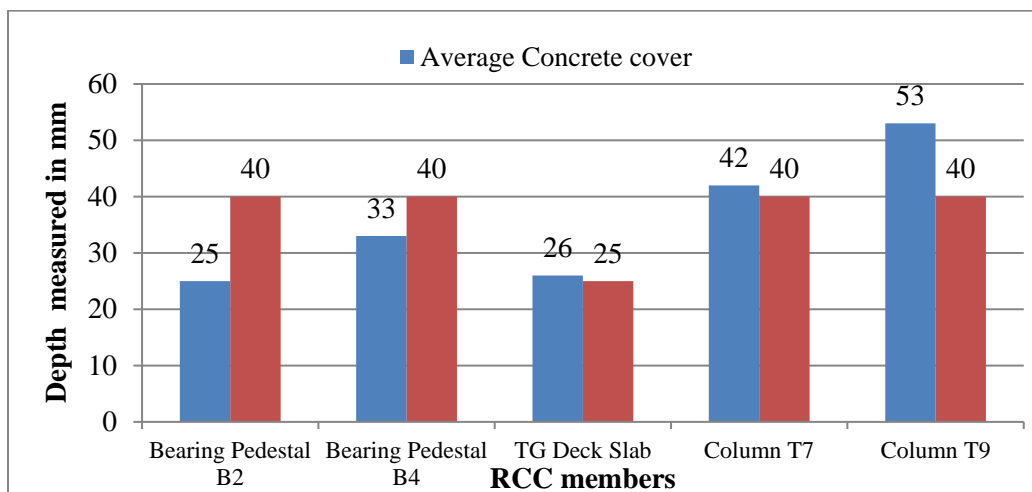
Profoscope instrument was used at identified locations on pedestals B2 and B4 for measuring the concrete cover thickness. The depth of concrete cover to reinforcement steel in the concrete bearing pedestals of B2 and B4 were 25 mm and 33 mm, respectively (shown in Figure 9). The existing concrete cover provided in these concrete bearing pedestals were satisfying the requirement of mild environmental

exposure conditions but not meeting the requirement of fire resistance period of 120 minutes as per provisions of table 16 and 16A of IS 456: 2000 [18]. However, at non-fire damaged portions i.e. TG deck slab and columns, both the requirements were satisfied.

Fig. 9 – Showing Nominal cover requirement as per table 16-A of IS 456: 2000 corresponding to the average concrete cover of RCC members of TG unit

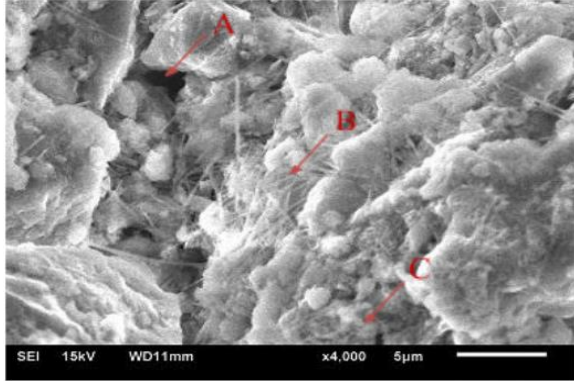
In this investigation, the S-400 Scanning Electron Microscope (magnification ranging from 20X to approx. 30,000X, the spatial resolution of 50 to 100 nm) was used to analyse the morphology. The fire-damaged pedestal B2 had shown disturbed or less densified microstructure. Micro-cracks gradually decreased from the depth of 35 mm to 50 mm from 50% to 20% respectively on fire-damaged specimens. The presence of hexagonal crystals was also observed at a depth of 10-15 mm for fire-damaged pedestal B2. The observations for SEM images of bearing pedestal B2 are made in figure 10, where A shows void and cavities due to release of moisture, B shows delayed Ettringite crystal with hair-like projections, C shows the presence of extending cracks [19], which indicates temperature may not cross beyond 350°C. The

Fig. 10 – SEM micrograph of a sample taken from Concrete bearing pedestal B2 at 30-35mm depth having a relatively loose microstructure

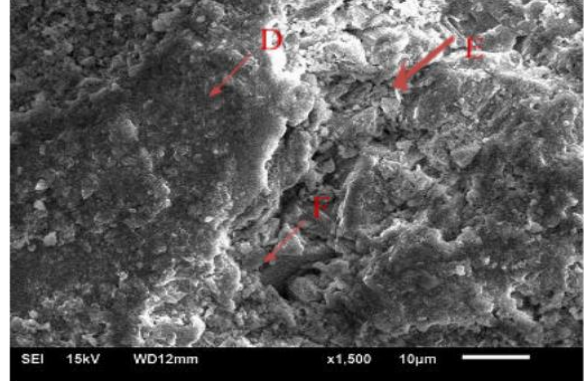
densified microstructure with Lath-shaped crystals is observed at a depth of 25-30 mm on a non-fire damaged bearing pedestal B4 sample. The observations for SEM images of pedestal B4 are made in figure 11, where D shows dense packing of concrete matrix, E shows grainy filling of cement hydrated

particles present in the concrete matrix of cement, F shows filled concrete matrix in void showing cement bound. The presence of Lath-shaped crystals suggests that the presence of ettringite or monosulphoaluminate minerals. These crystals are stable below 150°C of temperature.

Fig. 11 – SEM micrograph of a sample taken from Concrete bearing pedestal B4 at 25-30mm depth having relatively Densified microstructure

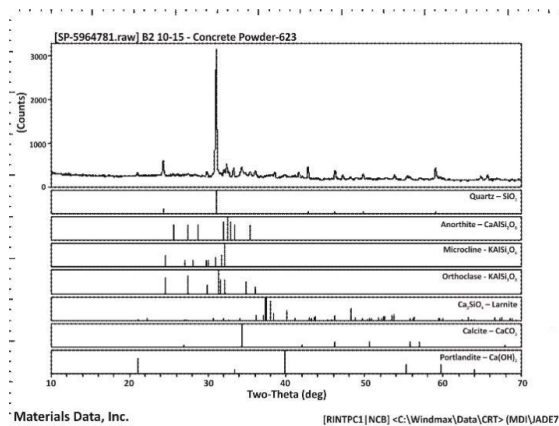
generated through powdered samples in the laboratory by using the X-Ray Diffraction technique (PANALYTICAL Expert Pro Powdered diffractometer with Copper Electrode and Ni Filter). In all samples of the bearing pedestal B2 and B4 across various depths, quartz was found to be in abundance along with other phases of feldspar, calcite and dolomite. In fire-damaged pedestal B2, portlandite was found at a depth of 10-15 mm, while in non-fire damaged pedestal B4, the same was found at 5-10 mm depth. This indicates the attended temperature may not have gone beyond 450 to 500°C from the above-mentioned depths in the pedestals.

Fig. 12 – XRD peak pattern for 10-15mm depth of Concrete bearing pedestal B2

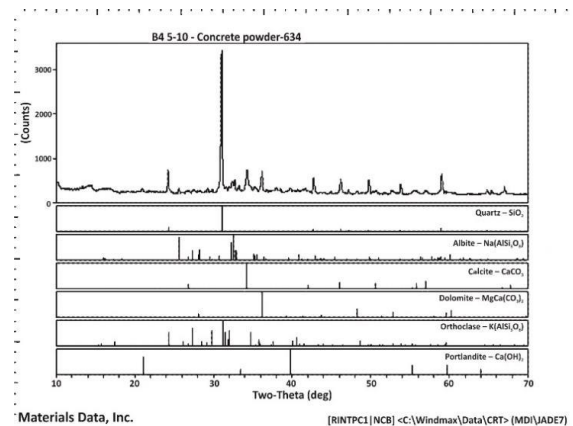
Fig. 13 – XRD peak pattern for 5-10mm depth of Concrete bearing pedestal B4

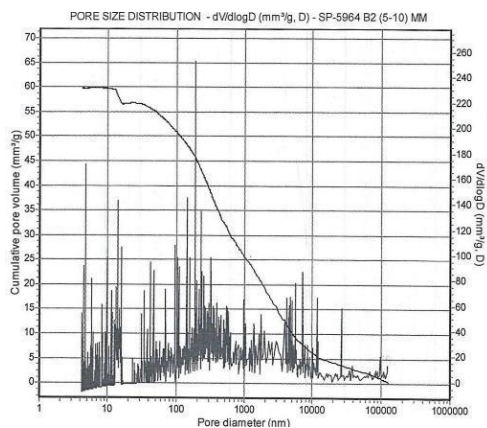
It is evident from the results that all the MIP parameters i.e. relative porosity, pore-volume, and the average pore size is higher for fire-damaged concrete sample when compared to the non-fire damaged sample [21]. The possible reason was the disintegration of CSH gel in concrete near the surface in B2, which is also observed in the SEM images. Pore size distribution of both B2 and B4 concrete bearing

Fig. 14 – Pore size distribution at a depth of 5-10mm of concrete bearing pedestal B2 (fire damaged)

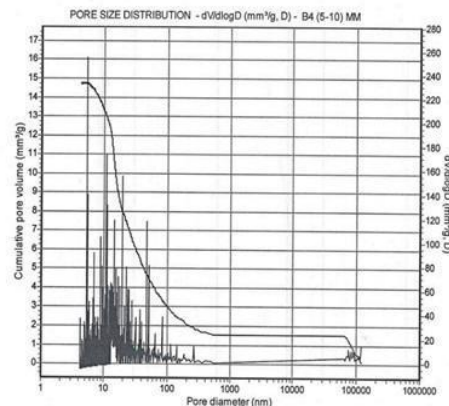
Fig. 15 – Pore size distribution at a depth of 5-10mm of concrete bearing pedestal B4 (non-fire damaged)

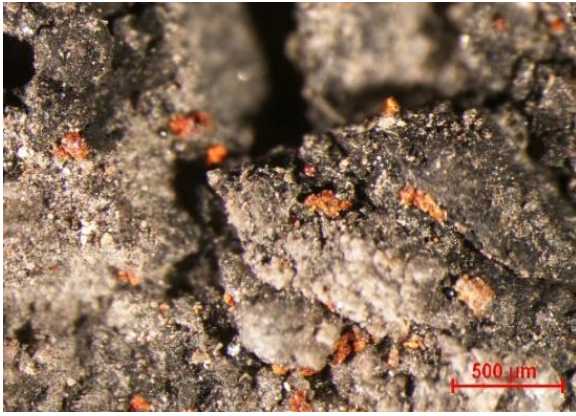
The stereo-zoom microscope (SMZ-1500) with Nikon Image system was used to observe the concrete samples extracted from different depths (shown as Figure 16 & Figure 17). The sample taken at a depth of 0-5 mm from fire-damaged bearing pedestal B2 shows that the concrete colour had changed to blackish-grey with a significant number of micro-cracks and partially oxidized fine aggregate. While in non-fire damaged concrete bearing pedestal B4 at a

depth of 0-5 mm, the presence of partially closed voids with relatively smooth margins were observed. Microscopic observations also showed significant parallel cracking toward the core axis in concrete bearing pedestal B2, indicating large-scale internal cracking, which may be due to internal shrinkage caused by overheating followed by rapid cooling due to fire-extinguishing.

Fig. 16 – B2-(0-5mm), Development of the cracked surface with partial oxidation of the fine aggregate

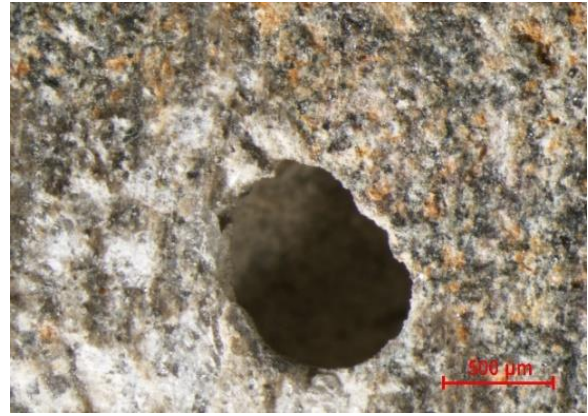
Fig. 17 – B4-(0-5mm), Development of an open void with smooth margins
