## Technical Paper

# Diagnosis of alkali aggregate reaction in concrete dams (an Indian case study)

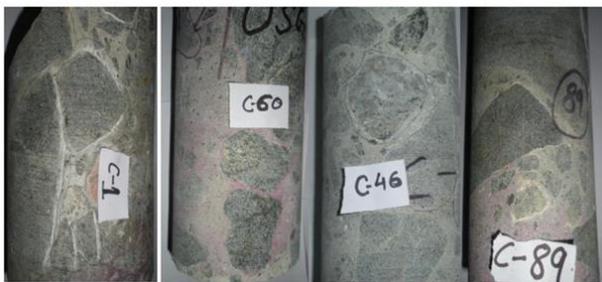
Visual observation of all the accessible portions of three Galleries including upstream and downstream portion of dam were carried out at site and on the concrete core samples extracted from different locations. The visual inspections of concrete cores indicated rims indicating chances of ASR (Fig. 2). Thereafter, samples from rim portion were also sent XRD, Chemical analysis, SEM, and petrography studies.

Fig. 2 – ASR rims from concrete cores extracted from different locations
