The durability and rehabilitation technologies of concrete sewerage pipes: A state-of-the-art review

Abstract: This paper reviews the literature available on the subject of the durability of concrete sewer pipes and the corresponding rehabilitation technologies. An introduction related to the importance of the sewer system in urban life and its durability issues was first discussed as most people did not recognise the scale and complexity of the underground sewer system. Then the recent development of alternative binder materials or filler materials to improve the acid resistance of concrete was specified. For instance, the effects of alternative binders on the hydration products and the mechanism of biogenic corrosion were discussed in detail. The paper ends with the current rehabilitation technologies and the structural performance of rehabilitated sewer pipes. Also, some suggestions associated with future research were made.

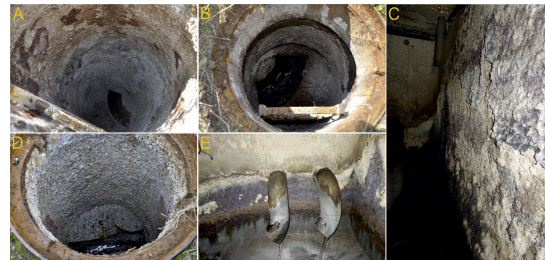
Fig. 3 – Photos of MIC in sewage facilities [17], Photos (A), (B), (D) are taken from the manhole of sewage pipes; Photos (C) and (E) are taken from wastewater catchment basins.

facilities that suffered from MIC (Fig. 3). To repair such deteriorations, a cost of around £85 million in the UK and \$390 billion in the USA is needed in the next 20 years [17].

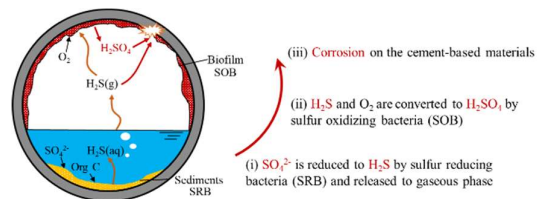
Fig. 4 – Schematic diagram of the MIC process in concrete sewage pipes

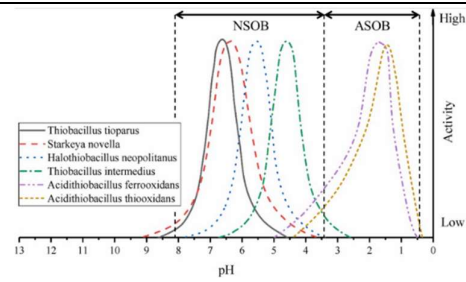
Fig. 5 – The SOB activity of different bacterial communities related to the pH value (modified from [30]); NSOB: Neutrophilic SOB; ASOB: Acidophilic SOB

Fig. 5 shows the relationship between SOB activity and pH values. The neutrophilic SOB (NSOB) first colonizes at the surface when the pH is between 4 and 9. Then, the surface pH can be further reduced below 4 with the continuing growth of bacteria communities. The acidophilic SOB (ASOB) will start to grow within this pH range and reach its highest activity at pH values between 1 and 2 [17,30].

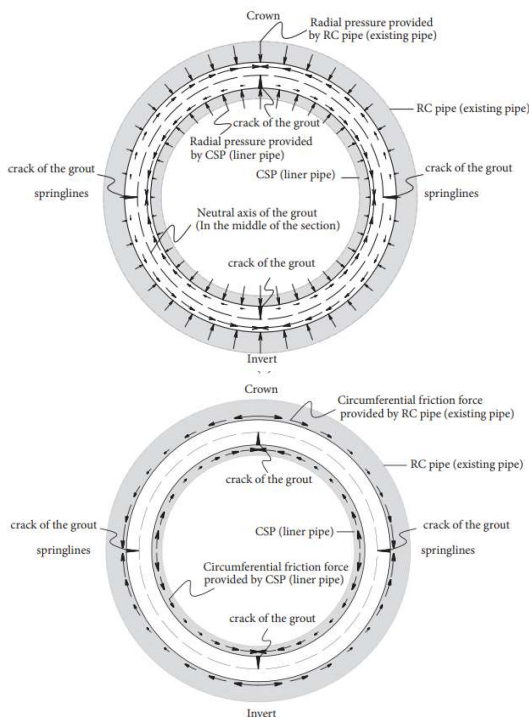
Fig.17 – Stress distribution of CSP-lined RCP [92]
